THE EVALUATION OF ASSETS QUALITY IN ALUN-ALUN KAWALI CIAMIS DISTRICT

Abstract — Alun-Alun Kawali is an asset belonging to the Ciamis Regency which is managed by Dinas Perumahan Rakyat Kawasan Permukiman dan Lingkungan Hidup which is located in the Kawali sub-district. Based on the results of a preliminary survey conducted in the field, indications of problems related to asset quality are found, including lighting, seating areas and parking lots. Therefore an asset quality evaluation is carried out using five dimensions, namely Architectural, Aesthetic, Social, Environmental, and Functional. The research method used is descriptive research. Data collection techniques used are observation and interviews. The results of the assessment in general show that there are several problems with 10 indicators out of a total of 16 indicators regarding the availability and condition of Alun-Alun Kawali assets which are still not in accordance with the standards.

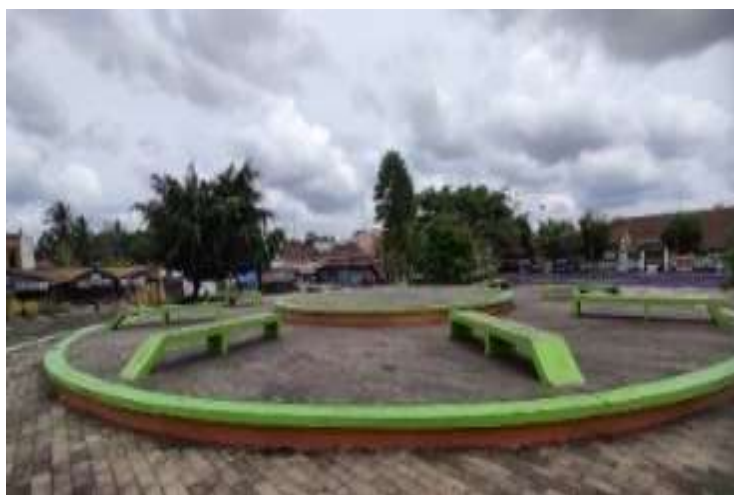
There are 9 seats provided in a circular position in the middle of the square. The seat is 0.42 meters high and 0.5 meters wide. Seating for visitors is in an open area without shade. These conditions do not comply with the criteria for comfortable seating in public open spaces, which need to be in a shady area [5].

Figure 1. Seating area in Alun-Alun Kawali

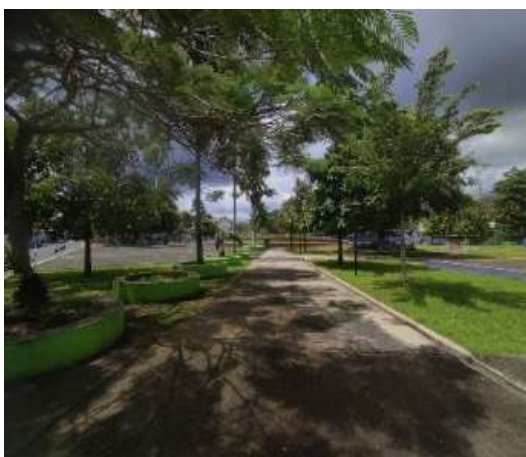
Figure 2. An example of The Condition of The Shade Trees in Alun-Alun Kawali

Based on the results of observations, there are 62 trees of different types in the Alun-Alun Kawali area. In general, areas where shade trees grow include pedestrian paths, sidewalks to the west of Alun-Alun Kawali, as well as several roundabouts dividing trees that can be used as seats for visitors. The shade trees in Alun-Alun Kawali have an average height of 3-10 meters. Trees that function as shade generally have shady leaves and have many branches. The shaded area produced varies from a radius of ± 110 centimeters to 480 centimeters. This condition is in accordance with the standard, namely the availability of trees that provide shady areas with the criteria of 3-12 meters high with shady leaves [8].

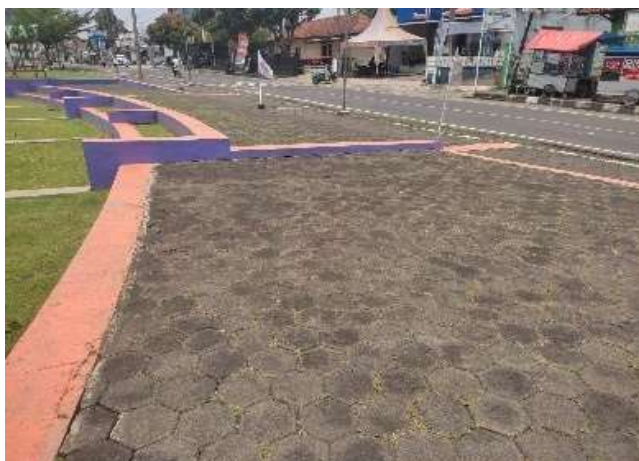
Based on the results of observations, there are two types of pavement materials used in Alun-Alun Kawali, namely paving blocks and reflection paths. Paving block materials are used on the sidewalks as well as on the pedestrian paths on the inside of the square. In general, the condition of the pavement surface is in good condition. No damage was found such as perforated surfaces or surfaces that have the potential to be slippery when it is wet due to rain. So it can be concluded that the criteria for a non-slippery surface material meet the conditions it should be [15].

Figure 3. An Example of Pavement Condition in Alun-Alun Kawali

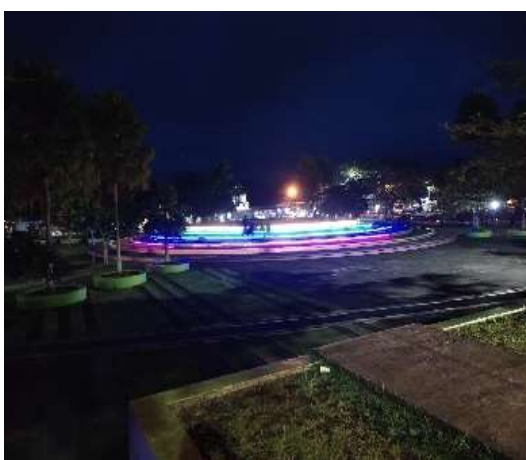
The condition of the lights at night is not entirely functional, for example for the northwestern pedestrian path there is only one lamp that functions out of the three lights in total. Based on the explanation above, it can be concluded regarding the criteria for the type of lamp, in general in Alun-Alun Kawali there are already available types of lamps according to their designation [17]. Based on the lighting conditions, some lights are not functioning and the lighting is uneven in all parts, so it can be concluded that these conditions are not in accordance with the conditions it should be, namely lighting must be evenly distributed in every part of the public open space. [16].

Figure 4. An Example of Lighting Condition in Alun-Alun Kawali

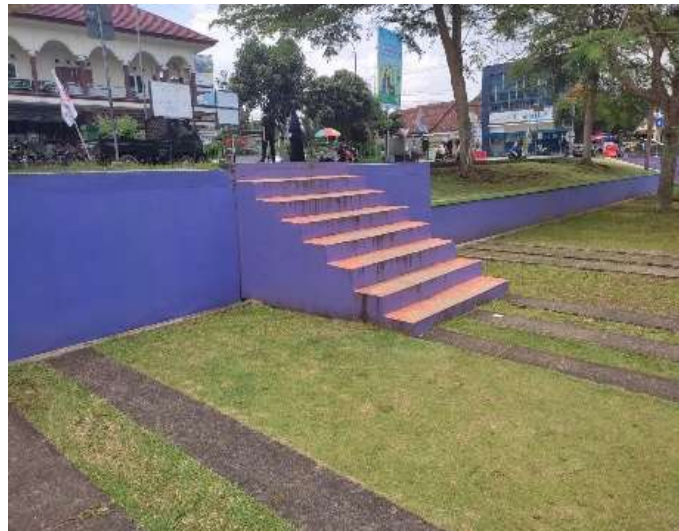
Based on the results of observations, there are no facilities that support accessibility for visitors with disabilities, especially for visitors who use wheelchairs or walker sticks. This is because the surface of the square has a different height from the main road and each entrance is only a staircase, which of course is difficult for wheelchair users to pass. In addition, there are no tactile paving (braille blocks) which could make it easier for blind pedestrians who need the help of a walker stick. This condition is not in accordance with the conditions it should be, namely as a public open space, Alun-Alun Kawali needs to provide facilities including for persons with disabilities, namely guideways and ramps. [22].

Figure 5. The Entrance to Alun-Alun Kawali

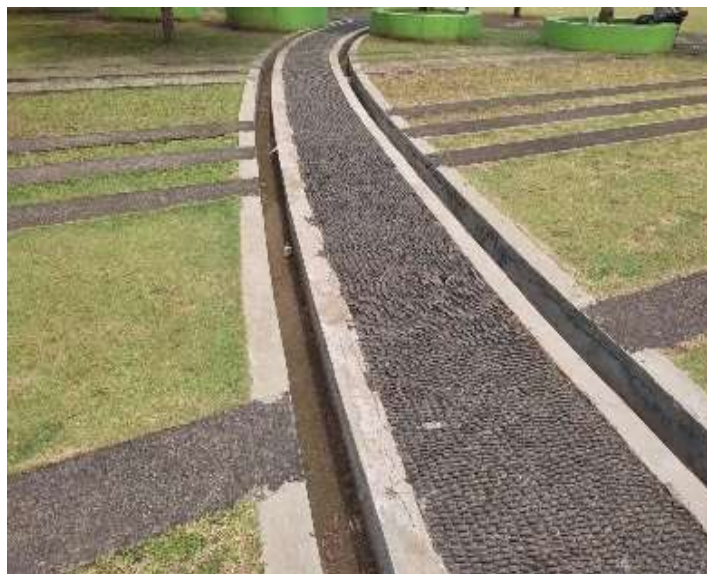
Based on the results of observations, Alun-Alun Kawali has provided special pedestrian paths, namely in the form of sidewalks and pedestrian paths on the inside of the Alun-Alun area. In addition, there are also drainage channels and shade trees in each pedestrian path. There are also three lighting lamps for each pedestrian path so that there are a total of 12 pedestrian lights with a range of 11.9 – 14.3 meters. Based on information from several vendors around the square, accidents, especially children who fall into open

drainage at Alun-Alun Kawali, often occur. Of course, this channel is risky not only for children but also for adults, especially for those who visit Alun-Alun Kawali for the first time or visit when it is dark.

Figure 6. Uncovered drainage in Alun-Alun Kawali
