Road Maintenance Management Using Pavement Condition Index (PCI) Survey

Tisara Sita
Balai Besar Pelaksanaan Jalan Nasional VII, Direktorat Jenderal Bina Marga,
Kementerian Pekerjaan Umum dan Perumahan Rakyat
Korespondensi: tisarasita@pu.go.id

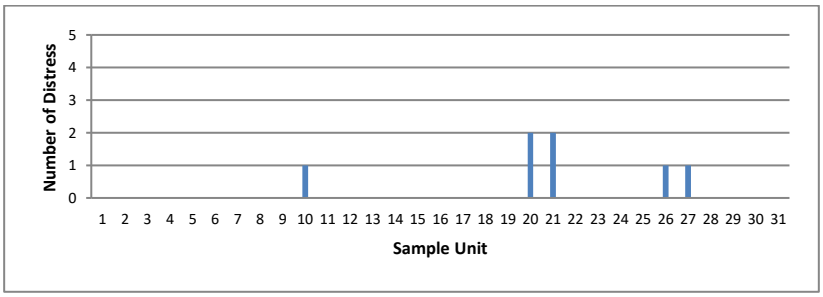
Figure 8. Number of Distress Types in each sample unit on Jl. Prof. Dr. Sardjito

PCI calculation results for each sample unit on Jl. Prof. Dr. Sardjito are on Table 5.2, the number of distress types in each sample unit can be seen on Figure 8, while the PCI Rating for Jl. Prof. Dr Sardjito can be found on Figure 9.

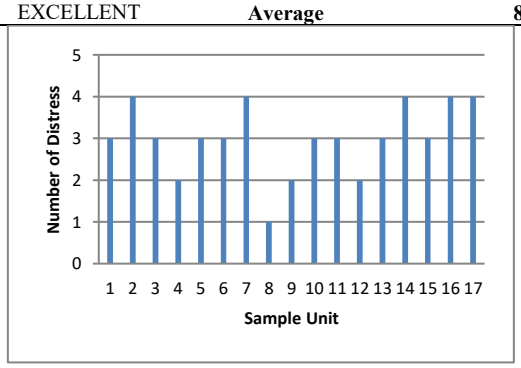
Figure 10. Number of Distress Types in each sample unit on Jl. Prof. Dr. Sardjito

PCI calculation results for each sample unit on Jl. AM. Sangaji are on Table 6, the number of distress types in each sample unit can be seen on Figure 10, while the PCI Rating for Jl. AM. Sangaji can be found on Figure 11.

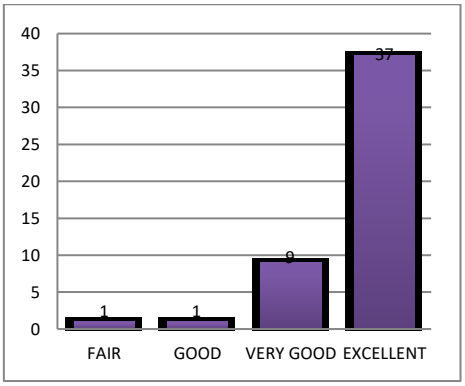
Figure 12. Road condition rating based on PCI calculation on Jl. Prof. Dr. Sardjito and Jl. AM. Sangaji

The road condition rating based on PCI calculation for both roads, Jl. Prof. Dr. Sardjito and Jl. AM. Sangaji can be seen on Figure 12, while the PCI distribution value for both roads can be found on Figure 13.
